Manhole Inspection Summary

Manhole # S57AA_004MH

Insp Date: **3/21/08 9:53 AM**

Location Address: **kresson st**

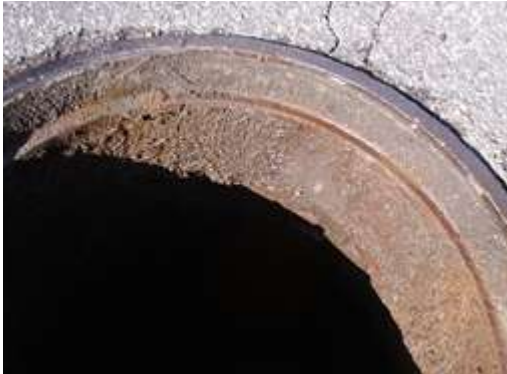
Defect 1

Frame Offset: **0** (in.) Condition: ☐ Sound ☐ Cracked ☒ **Leaks**

frameleaks

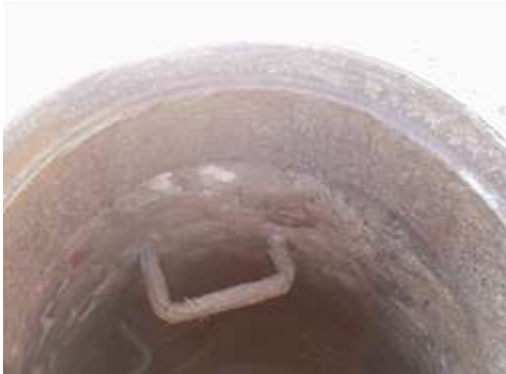
Defect 2

Condition: ☐ Sound ☐ Cracked ☐ Root Intrusion ☒ **Loose Brick** ☐ Deteriorated

Infiltration: ☐ None ☒ **Joint** ☐ Cracks ☒ **Mortar** ☐ Roots ☐ Wall

adjustment joint

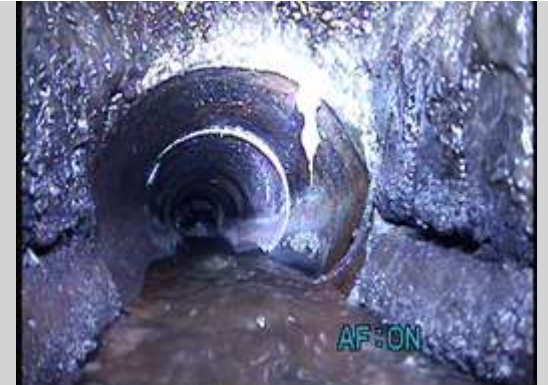
12 O'Clock Outflow

8 in. Circular Gravity Sewer
Pipe Out @ 12 O'Clock

Pipe Height: **8.4** (in.) Rod and Bar (Angled)
Pipe Material: **Clay** ☐ Pipe Lined
Invert Depth: **8.30** (ft.) Flow Characteristics: **Fast**
Deposits: ☒ None ☐ Mud ☐ Sludge ☐ Debris ☐ Grease
Silt Depth: (in.) Deposits Extent:
Infiltration: **None** Pipe Seal Cond: **Sound**

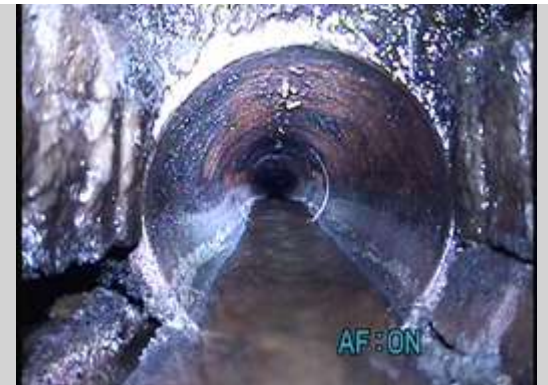
6 O'Clock Inflow

8 in. Circular Gravity Sewer
Pipe In @ 6 O'Clock

Pipe Height: **8.4** (in.) Rod and Bar (Angled)
Pipe Material: **Clay** ☐ Pipe Lined
Invert Depth: **8.20** (ft.) Flow Characteristics: **Fast**
Deposits: ☒ None ☐ Mud ☐ Sludge ☐ Debris ☐ Grease
Silt Depth: (in.) Deposits Extent:
Infiltration: **None** Pipe Seal Cond: **Sound**
